FACILITY COMPLIANCE INSPECTION REPORT

Division of Waste Management Solid Waste Section

Date of Site Inspection: December 16, 2013 **Date of Last Inspection:** August 8, 2013

Columbus County LCIDLF
Landfill Road
Whiteville, North Carolina 28472

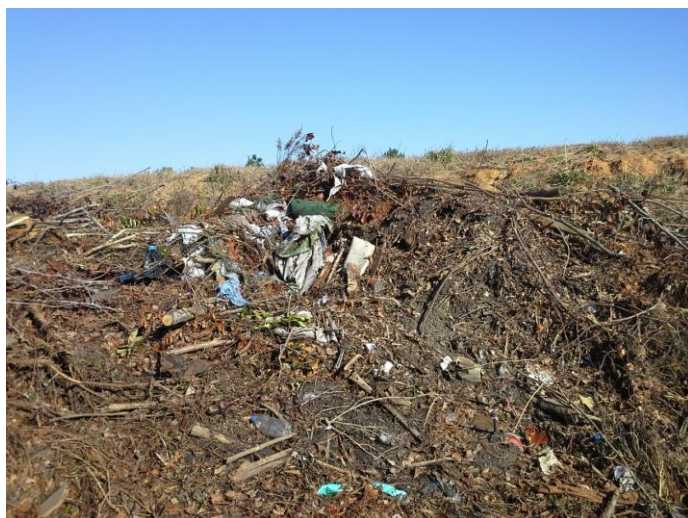
1

1. Carpet and plastic (was removed the day of the inspection).
2. Perimeter road stormwater ponding should be addressed to prevent back-up onto the slope soil cover
